# SAFETY ALERT

Fatal accident.

**Nature of Incident/Injury:**

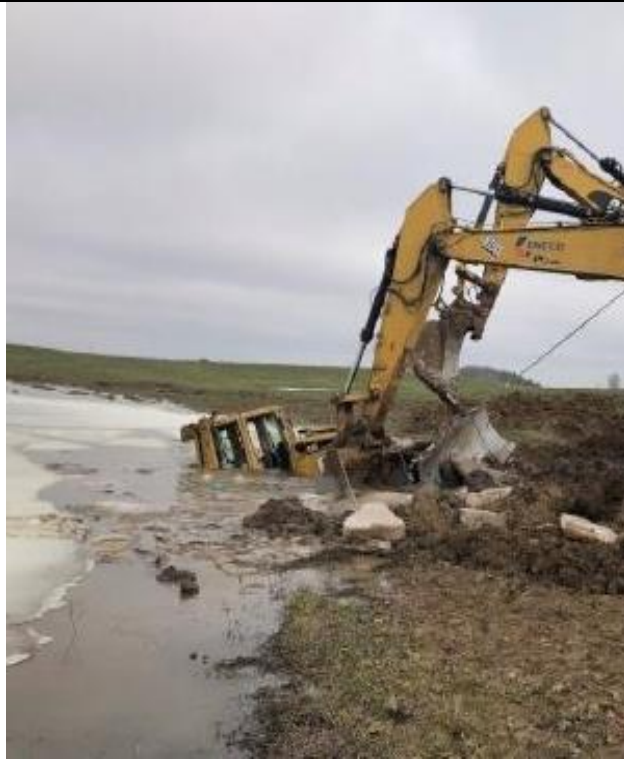
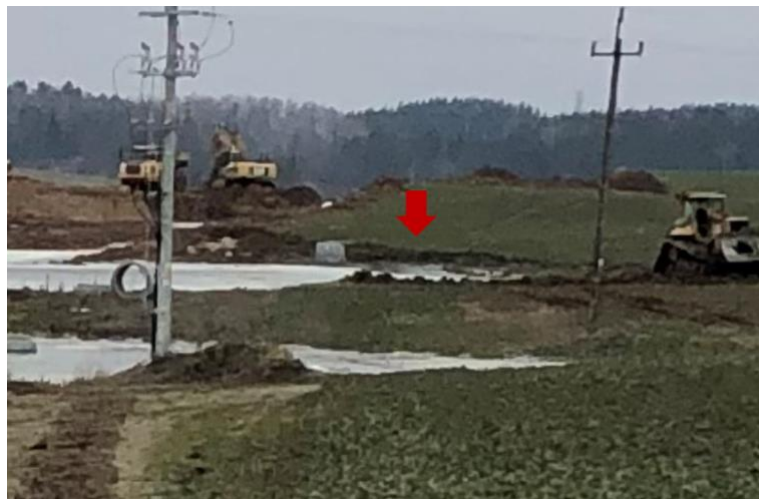
On the road construction site, during a passing of bulldozer CAT D6N crossing the plough field on the border of the construction site on the start work place direction, a crawler dozer operator of a subcontractor company, drove into the floodplain with an accumulated meltwater. It was over the dozen a centimeters long of ice on the Surface, in some place the floodplain the ice cover was partly thaws. The machine was almost completely submerged under water. Thanks to a signal light on the dozer, one of the workers noticed the machine was submerged. The actions of taken to lift the cabin from under the water and set operator free was immediately. Unfortunately, the rescue operation wasn't restore a life of dozer operator. The site of floodplain was visible, The operator was 62, he was experienced employee. On this construction site he worked since 2,5 months. He worked on draining the area on a daily basis, so he known this area, location, boundaries and depth of the floodplain. On this moment we don't know reasons of the operator demeanor. We don't rule out internal causes too. The machine was operational.

Clear marking of hazardous places – full of water floodplain, drainage tanks, which could be a big or unknow depth, unrecognized subsoil, steep walls. Familiarizing employees with a dangerous places, determination the communications roads for daily morning meeting before start the work.
