SAFETY ALERT

Type of Incident:

Falling

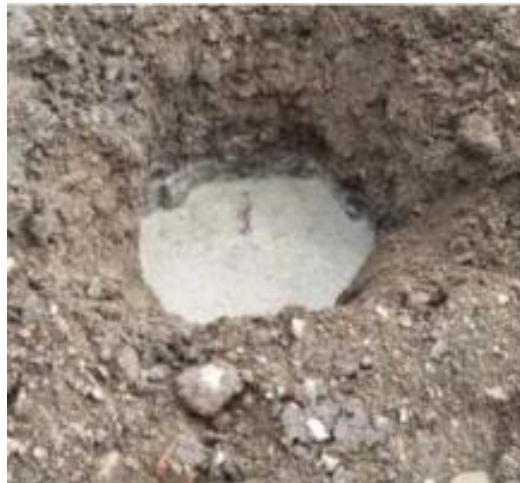
A 450mm auger was 15 meters into the ground and disconnected from the rig. The auger remained vertically stored for a period of two weeks before being back screwed and removed from the ground. On the removal an operative stepped onto a soft spot created by the auger removal, which collapsed inwards under his weight. This resulted in the operative falling over and suffering bruising to upper arm. No lost time incurred.

The investigation concluded the area around the auger removal had been insufficiently backfilled. This exacerbated by a period of extremely wet weather, resulted in the ground around it collapsing inwards when stepped on.

Following any auger being extracted from vertical storage, the location shall be suitably backfilled and compacted by an excavator.

On completion of backfilling, it should be noted the ground consolidation takes time. Therefore, measure should be taken to ensure the drilled location is physically fenced off a minimum of a further 24hrs and monitored. Should the ground further subside during this period, further backfilling of the location is required until no further ground collapse occurs during the following 24hrs period. These checks should be carried out by the piling supervisor.

Restriction to the drilled location should only be realised upon the confirmation of sufficient ground condition following a 24hr period of monitoring.
