SAFETY ALERT

Details of Incident:

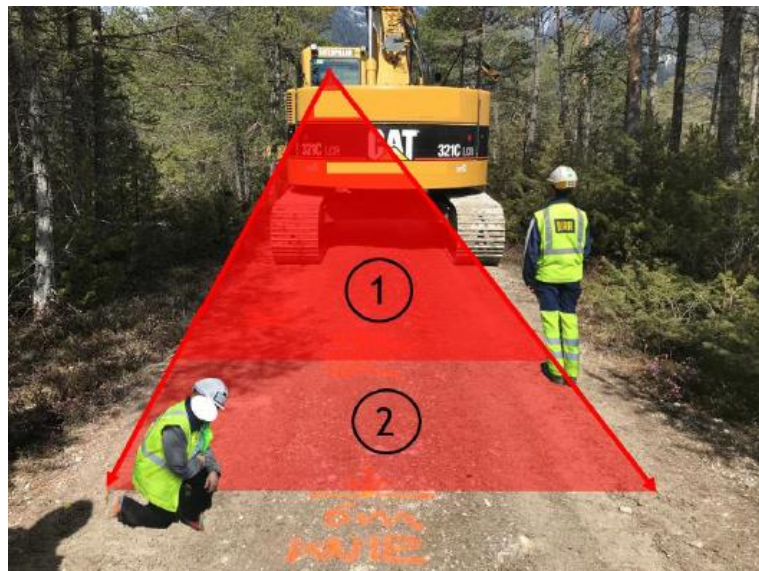
An excavator was in the process of reversing and one of the employees was behind the excavator in a kneeling position. Being in a blind spot, the victim was outside the field of vision and was run over seriously injuring his foot.

- 1./ Lack of visibility from the excavator when standing
- 2./ Lack of visibility from the excavator when kneeling.

Unsafe position and lack of exclusion zone
Lack of safety devices: rear view camera, alarm system

Evaluation of field of view earth-moving machines. (Rear view camera, banksman...) No stay in the danger zone. Blocking off the danger zone. Communication between operator and site personnel.
