SAFETY ALERT

Tipped Crane

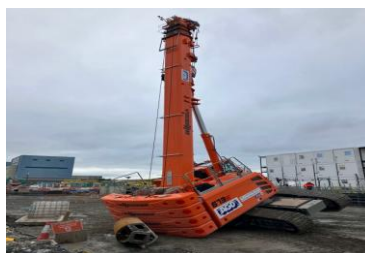
During a de-rigging operation, a Sennebogen 673, 60T Telescopic Boom Crawler Crane tipped and came to rest on its counterweight after slewing 80° from track alignment. The incident occurred in an authorised zone. The crane was being prepared for transportation following the completion of contiguous piling on the K8A platform. With the telescopic boom raised and oriented towards the east, the crane's tracks had been retracted and securing pins installed at the rear of the chassis by the travel motors, and at the front of the carriage. The crane operator realised that the slew lock pin was at the same end as the track motors and made a decision to slew the carbody 180° to the west in order to lock the cranes slew rig. When the carbody had rotated and the counterweight was positioned overhanging the track carriage (with the telescopic boom still raised), the centre of gravity and balance point was exceeded, and the crane tipped slowly back, coming to rest with the counterweight on the ground

Although the operator arrived at the site as a suitably qualified person with a blue CPCS card, they were not the crane's regular operator. The crane on the site was not handed over by either the departing operator, who had mobilised the crane or an AGD fitter who was aware of the operational requirements and crane's safety systems.
