Date of incident:	08.12.2023	Incident type:	High Potential Near Miss (HiPo)
Incident ref:	iSMS - 682856	Contractor:	SB3JV
Location:	Old Oak Common	Issued by:	
Keyword Search:	Lifting Operation

Summary of Incident

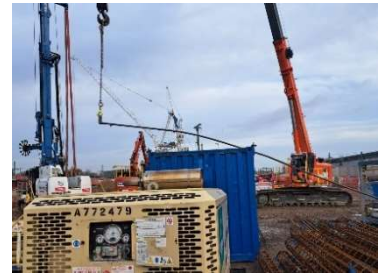
The slinger signaller requested the crane driver, to lift the bar from the horizontal position on the trestle, to a vertical position. Once in the vertical position, with the bottom of the bar just above ground, the slinger requested the crane driver to lift in order to move the bar to the pile location. The bar detached from the lifting head in its vertical position and fell onto the SB3 stores container within the restricted zone.

Bar came to rest on container

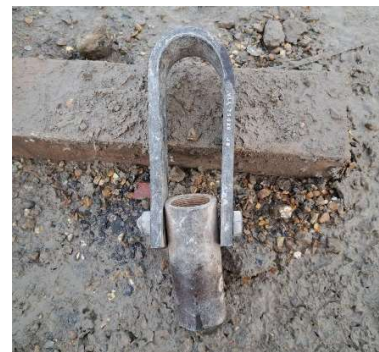
- No manufacturer's details or information on the use of the single bar lifting head had been provided.
- The lifting head was a proprietary coupler that has been adapted by the reinforcement supplier for bar lifting purposes. The coupler manufacturer states that it cannot guarantee a load if imposed on them in the horizontal position.

- Specific job training for attaching the lifting head had not been given to the slinger signalers.
- No mechanical failure of the rebar lifting head, or the threaded rebar, has been identified.

Rebar Lifting Head

- All 'Rebar Lifting Heads' are to be taken out of use and quarantined until further notice.
- 'Single Bar Lifting Clamps' are to be introduced as the alternative method of lifting and placing reinforcement bar.

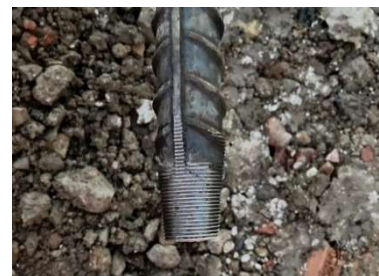
Rebar with threaded end

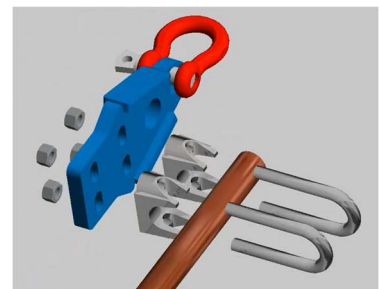
- A single bar lifting clamp had been designed specifically following a previous incident with similar findings.
- A secondary backup sling arrangement that was used when working alongside a Network Rail asset was not utilised once the piling works moved into the centre of the site away from the railway.

Single Bar Lifting Clamp

- A secondary sling must be attached to the bar/hook and that this is recorded in the lift plan & risk assessment.
- All slingers are trained in the pre-use checks, inspection and fitting of the single bar lifting clamp.

- The Task Briefing Sheet must be updated to include the specific fitting and installation instructions.
- The lift plan and associated documentation must be updated to include the single bar lifting clamp.

- A hold point must be put in place at the point of attaching the lifting accessories to the crane.
- To ensure that the bulldog grips are correctly torqued up to the bar/lifting clamp.
