# SAFETY ALERT

Coupling Failure

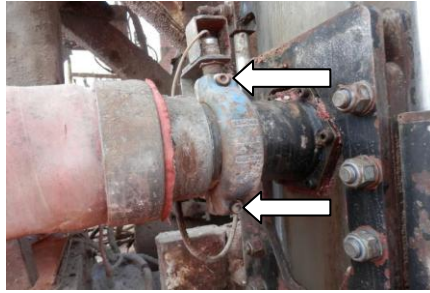
Material failure of part, possibly due to fatigue or incorrect tightening of the bolts.

Arrows pointing at the cap head bolts which failed on the changeover valve clamp.

The Mecbo Beton Cap tracked agitators servicing is every 250 hours. The cap head bolts will be replaced following a 250 hour service. Bolts are to be replaced to the correct grade and tightened to the correct torque settings as per manufacturers guidance. The same maintenance regime will be applied to all other agitators with similar clamps
