# SAFETY ALERT

Unstable Piling Rig

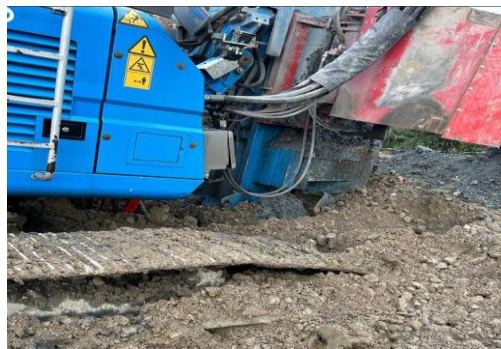
On the day of the incident the site team had just bored a 350mm x 10.5m pile when the concrete pump broke down. Needing to clear the concrete lines the team pulled off the pile and were in the process of tracking back away from the pile when the front of the rig tracks started to sink. Attempts to reverse and then track forward only made the rig sink further. The rig operator lowered the mast foot, and the attendant excavator was used on the rear of the rig to provide additional stability to the machine. Management attended site and the rig was safely recovered to a stable position, where upon an investigation commenced. The Investigation determined that a soft spot was present in 'firm clay' subgrade that had gone unnoticed /un-remediated. The design assumptions and the design allowed for two assumed subgrade strength values. The PC adopted the stronger value and therefore a reduced platform thickness, but still within the design. A 6F2 fill was to be used but the as used platform material was questionable and likely not to have been as specified. No grading certs were provided. Plate load testing had been carried out and did not show any cause for concern. The platform installation methodology could not be confirmed.

Failure to manage the platform installation in accordance with the design

- Soft spot not identified and remediated
- Suspect 6F2 material used

Platform was remediated with a lean mix concrete and increased platform thickness, and additional plate load tests were completed.
