SAFETY ALERT

The below information has been issued on behalf of the EFFC to make others aware of the potential risks and possible precautions to take in order to avoid these.

Risk of being struck by whipping cable

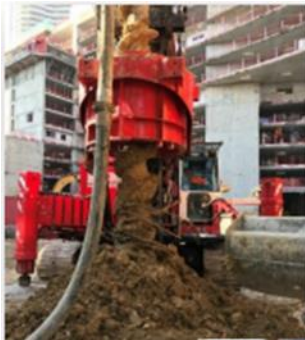
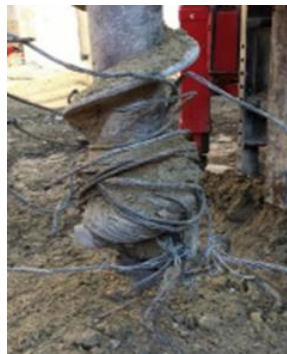
A crew was performing an operation in an area where old anchorages were located. During drilling, the auger hit an old buried anchorage (not identified on the drawings) that got twisted on the auger. Once the drilling was completed, the tool is gradually raised (concreting phase). When the foot of the auger came out, the tensioned anchorage is abruptly unrolled, sweeping a 4m radius around the auger, almost hitting personnel, who were however standing outside the machine's restricted zone

Failure to identify underground services or elements: The anchorages were not listed on the piling drawings plan

1. Widening of the restricted zone when the auger is extracted from the borehole
2. Awareness of tender engineers and site managers on the importance of having all the elements (drawings/plans) upstream of the operational phase.
