SAFETY ALERT

Type of Incident:

Near miss.

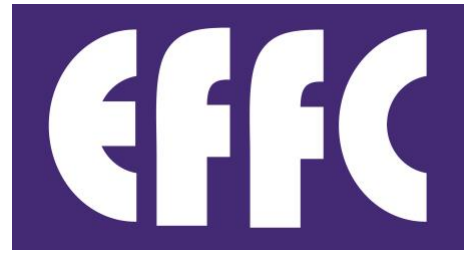
The shotcrete silo was underlaid with wooden posts. On the day of the incident, the silo was filled. The total weight was about 43 tons. During the day, the silo tilted to the side and eventually fell onto a garage. The garage was completely destroyed. The cars inside were totally damaged.

The installation site must be level and load-bearing. Observe the manufacturer's maximum permissible angle of inclination. If the load-bearing capacity of the ground is insufficient, construct a foundation. Observe the necessary safety distances to excavations and slopes. Pay attention to settlements during filling.
