SAFETY ALERT

Details of Incident:

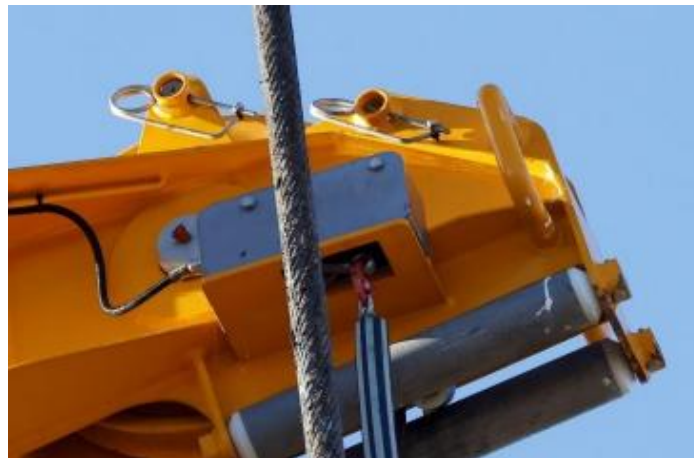
It had been identified that a rope guide pin had fallen from the CAT head of the BG45 whilst in the vertical position. Further investigation identified that the rope guide pin had fallen from the auxiliary line. The securing pin had still been in its original fitted position within the CAT head as seen in the below image.

Human Error. The securing pin had not been seated through the rope guide pin during installation. The securing pin had pushed the rope guide pin out of its fitted location approx.10mm

- All Bauer Technologies Piling Rigs inspected. No further discrepancies identified
- Information shared with Bauer Maschinen to seek potential engineering resolution.
- During the rigging phase, all operators are to check that the rope guide pins are correctly installed prior to the mast being elevated.

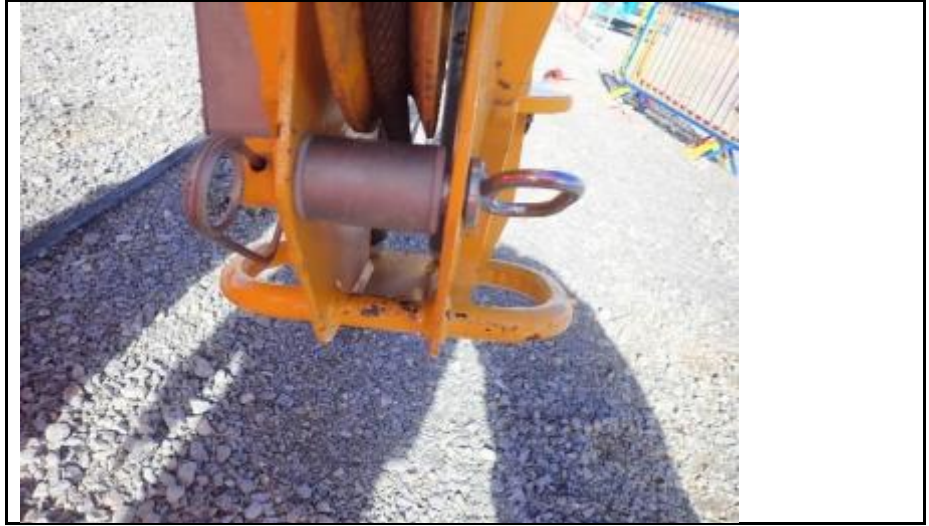
Adding a correctly fitted rope guide pin with securing pin to keep worker safe.
