SAFETY ALERT

Accident with High Potential

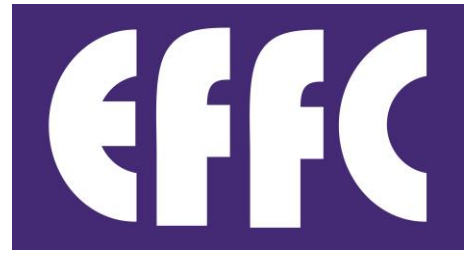
While performing concreting work, the concrete hose became blocked. When trying to "flush out" the concrete with air pressure, a jerky dissolution of the concrete occurred. As a result, the concrete hose, which was not secured against movement, whipped uncontrollably and hit the leg of an employee who was standing in danger zone

Clogged hose. Unsecured hose. Inadequate planning of the task

Do not stay in the danger zone. Secure the hose and install whip -checks. Locate blockage and clean segments separately. Installation of a catch basket at the extreme end of the hose. Flushing with water by a specialist company.

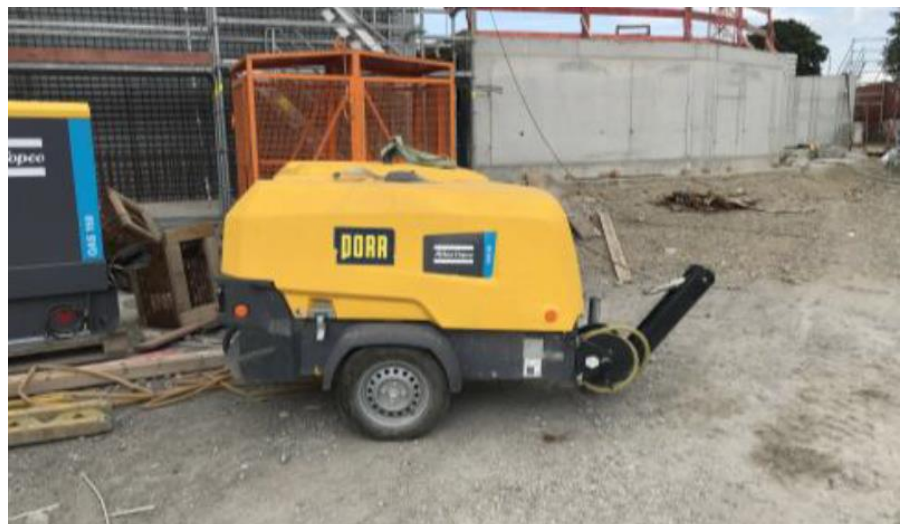
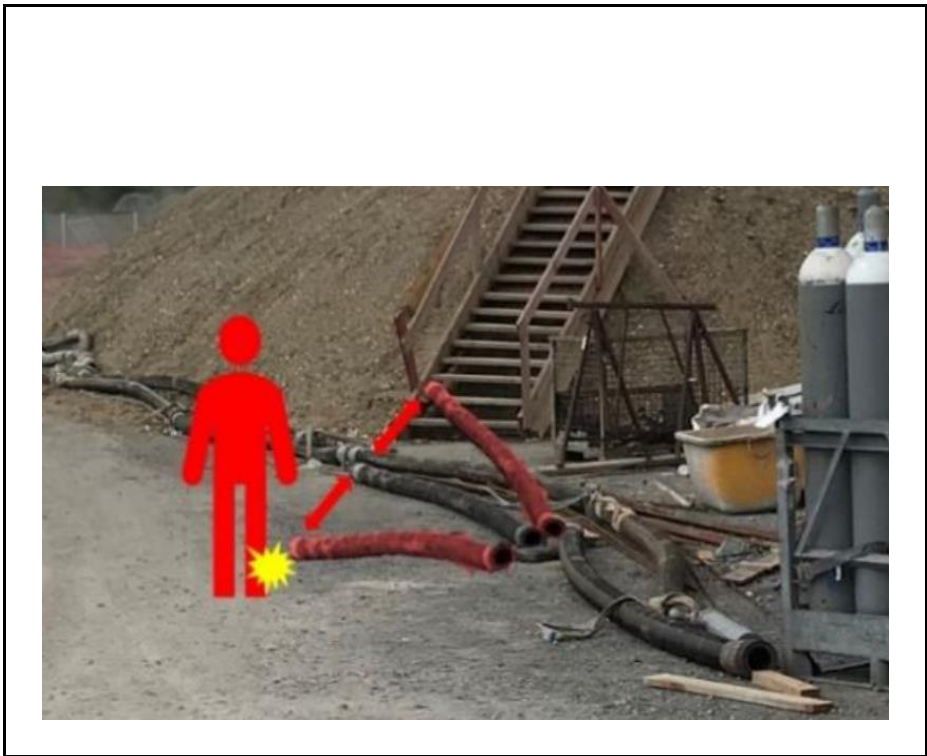
Further potential hazards due to whipping of the pipe and projection of material.
