SAFETY ALERT

Partial Amputation to fingers.

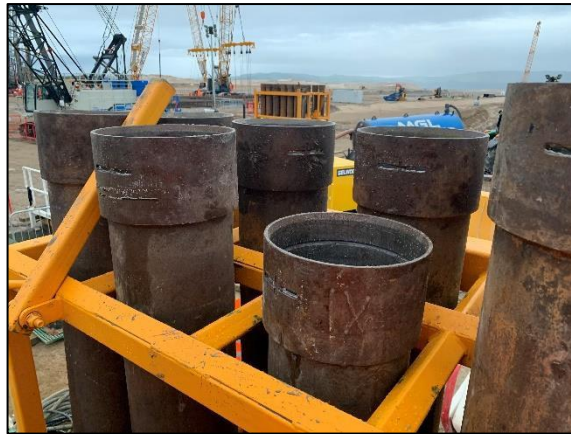
Lead tremie placed in tremie rack after the incident. The collar had been 100mm lower during the incident.

Mechanical – Modification made to 3m tremie sections to be used as a lead tremie was 300mm shorter than the rest. Tremie racks modified to counter the reduction in length. This prevents the lead from being placed in other compartments.

- Modifications made to tremie racks removed.
- Lead tremie sections lengthened to 3000mm, design of the lead tremie modified to allow stable storage in the tremie rack.

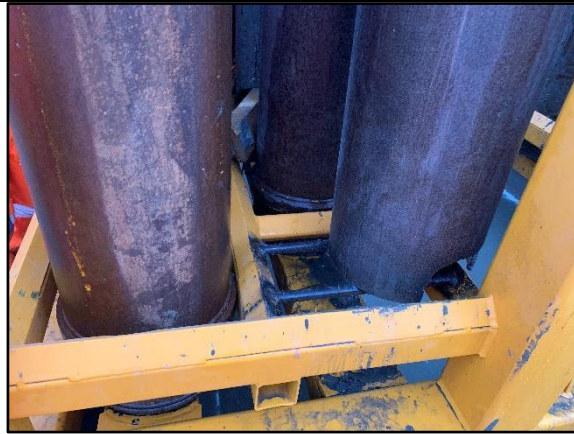
Modification made to tremie rack to accommodate the lead tremies.

Systematic – No consistency with the modifications made to the tremie racks or lead tremies. All tremie racks differ in the modifications made, the lead tremies all modified in a different manner to allow for concrete dispersal.
