SAFETY ALERT

Drill rig topple

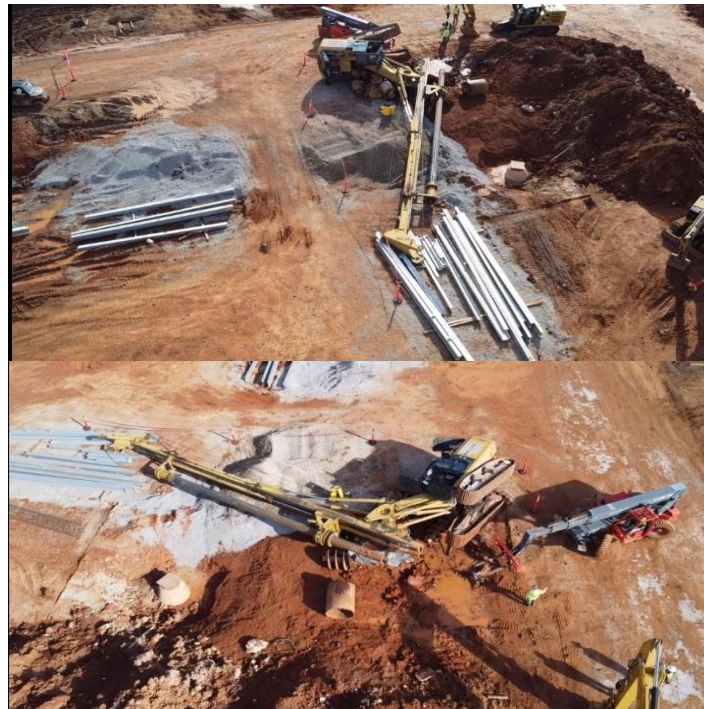
- Machine configuration
 - The rig tracks were retracted.
 - Kelly bar remained on the machine.
 - Mast remained vertical.
 - The machine was being moved in the above configuration at the time of the incident.

- The operator must be qualified/evaluated to operate the specific rig they are assigned to.
- The operator shall demonstrate an understanding of the operator's manual for the specific rig they operate.
- The operator shall conduct and document a pre-start safety inspection of the equipment they are assigned to operate – Daily and/or at the start of every shift.
- The operator has the right and responsibility to refuse any signal from a ground employee that is questionably and/or knowingly unsafe.

Under no circumstances are rig tracks to be retracted unless the rig is being dismantled and loaded/unloaded according to the manufacturer's recommendations.

Manufacturers recommendations vary depending on the make and model. What is safe for one drill may not be safe for another. Mast and track positioning, levelness of platform, and utilisation of the auxiliary line all influence the center of gravity of the drill rig directly impacting stability.
